## HIGHWAY ACCIDENT REPORT

PROPANE TRUCK COLLISION WITH  
BRIDGE COLUMN AND FIRE  
WHITE PLAINS, NEW YORK  
JULY 27, 1994

**Adopted: November 14, 1995  
Notation 6479A**

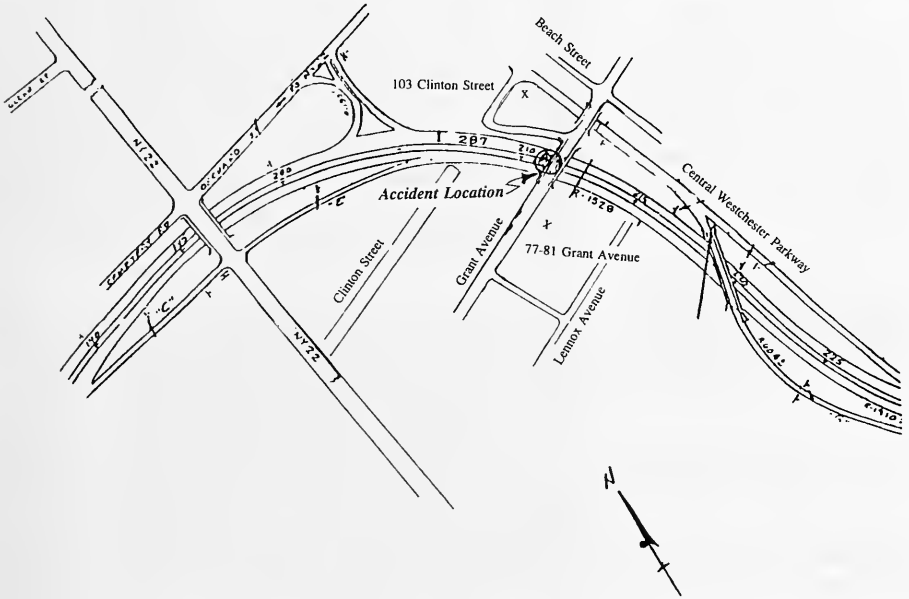
**Highway Description** -- The accident occurred on a 1,550-foot-radius (centerline radius) curve to the right on a 2.26-percent downgrade. (See figure 11.) The curve was 2,246 feet long and had 250-foot-long spiral transitions at each end. The centerline of the Grant Avenue bridge was 1,750 feet from the beginning of the curve. The bank or superelevation for the curve was +0.06 (percent). At the accident site the left shoulder slope was approximately -0.02 and the embankment foreslope approximately -0.16.

Figure 11. – Plan view of accident site

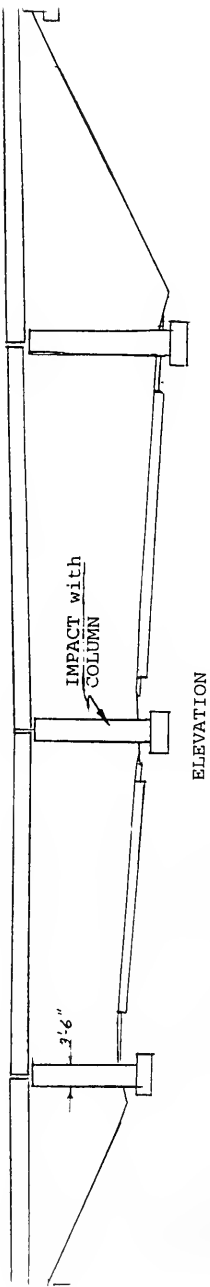
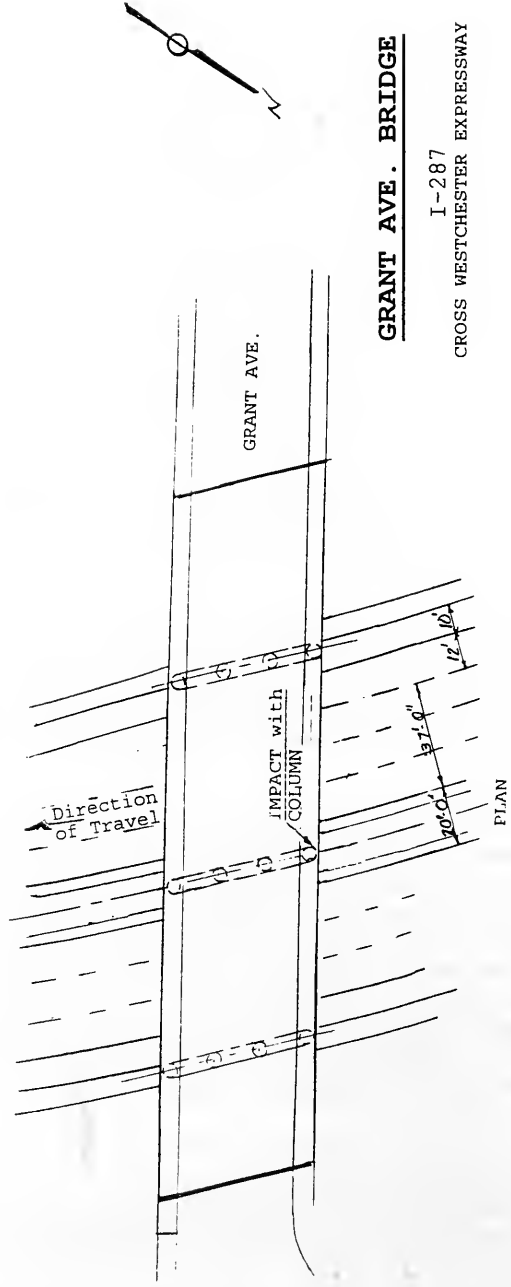
**Grant Avenue Overpass** -- The bridge was a steel girder structure consisting of four simply supported<sup>37</sup> spans of eight girders each and was supported by three piers and two abutments. The reinforced concrete deck was 54 feet wide. The bridge was 232 feet long and formed an angle of 76 degrees with I-287. Each pier consisted of four 3 1/2 foot diameter reinforced concrete columns connected by a reinforced concrete pier cap. The columns were built along a straight line, and each rested on an isolated spread concrete footing. The faces of the 14-foot-2-inch center pier columns were 8 feet from the traveled way. (See figure 13.)

Figure 13.--Schematic of Grant Avenue overpass

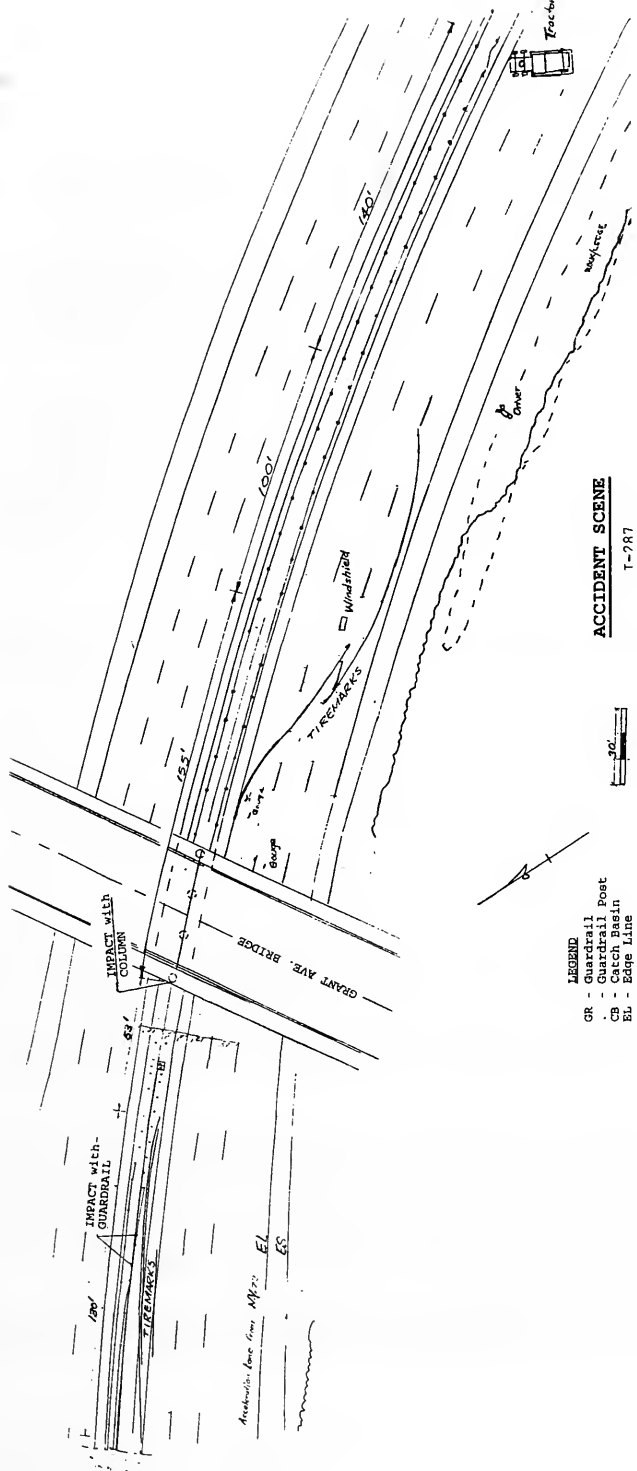
**Postaccident Physical Evidence** -- Safety Board investigators documented 130 feet of tiremarks in the eastbound lanes of I-287. The marks began approximately 200 feet in front of the bridge column in the left lane and continued to the shoulder and foreslope of the drainage ditch. Near the end of the 130 feet, the marks started curving back to the roadway. The marks left the traveled way (across the pavement edge line) and the shoulder at an angle of 5 degrees. (See figure 14.)

Figure 14.--Accident scene

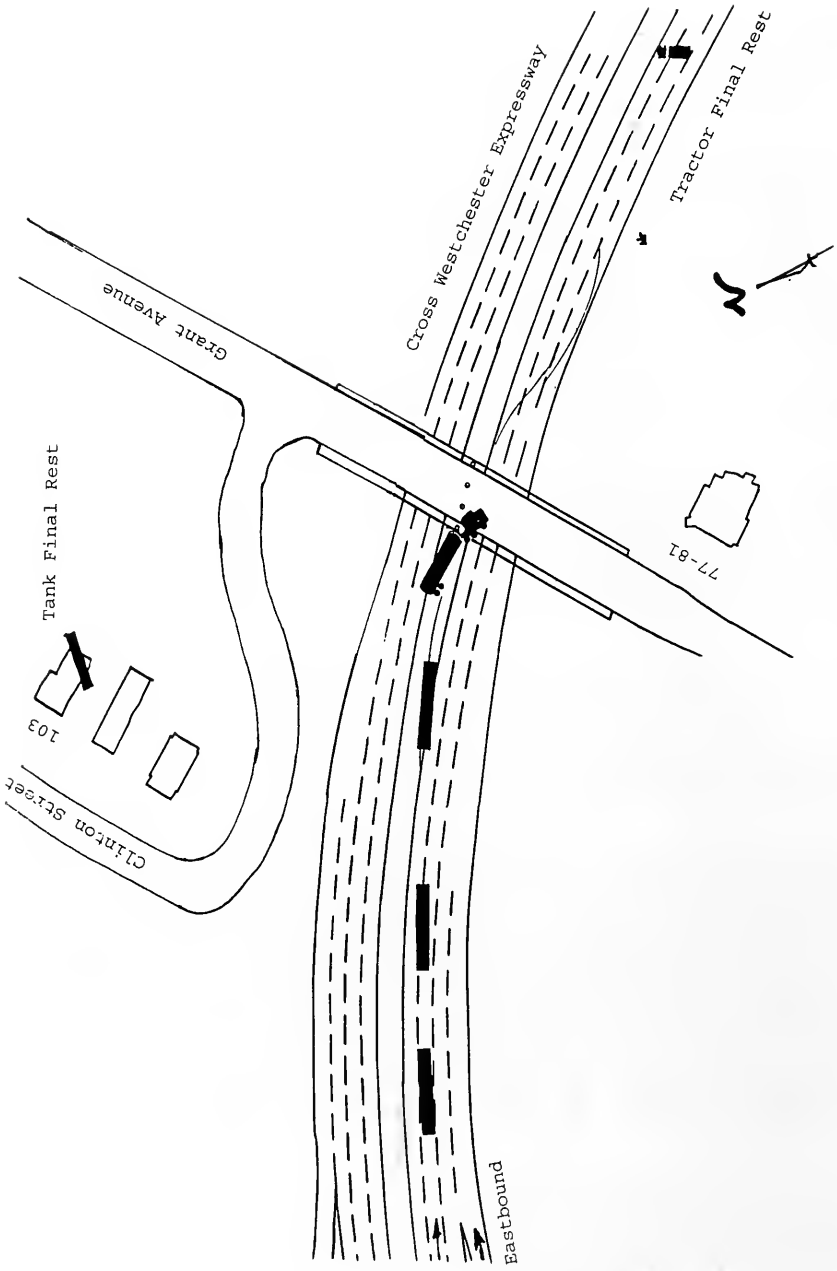
**Vehicle Instability/Rollover** -- The witness said it appeared that the left side of the truck struck the guardrail and the tractor ricocheted off the guardrail and went to the right. The tire loading marks made by the left outside semitrailer tires began at the left-lane edge line, 185 feet from the west bridge column, and arced toward the right. The maximum radius of the marks was 930 feet. (See figure 15.)

Figure 15. - Rollover sequence
